PI3EQX7841/PI3EQX7502AI/PI3EQX7741/PI3EQX7742/PI3EQX501/PI3EQX502

USB3.0 re-driver debug App Note

By YT Tso and Anne Wu

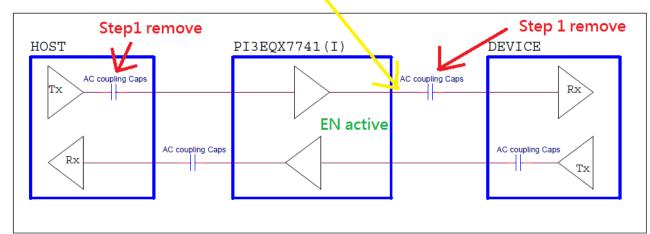
Block Diagram

Please check the redriver function as below block diagram first, before start to fine tune the equalizer and Deemphasis setting.

Step1. Remove AC coupling capacitor as below

Step2. Measurement the place in redriver output, then you can see the detection pulse without connecting device

Step 2 probe SS+

How to know re-driver is working

Check can see 500mV CLK, means correct

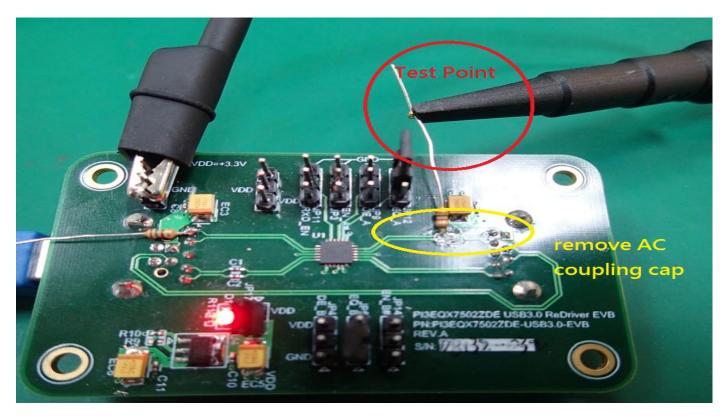
Figure 1(a) top view of PI3EQX7741ST EVB
